N63R Map Thermostat Faults

This Service Information bulletin replaces SI B12 13 16 **dated July 2016**

G12 (750i sedan)

With the N63R engine
------------------	--

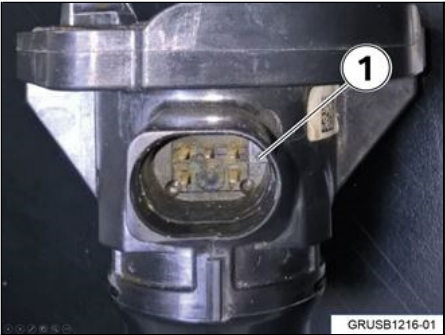
Coolant is leaking past the map thermostat electrical connector.

<p>GRUSB1216-01</p>	<ol style="list-style-type: none"> 1. Remove the connector for the map thermostat (1) and check for coolant. <p>Is coolant present in the engine wiring sensor harness for cylinders 1-4?</p> <p>YES - replace the map sensor thermostat (PN 11 53 8 602 282) and the sensor harness (PN 12 51 8 654 414). Go to step 2.</p> <p>NO - continue diagnosis by performing the associated test plan in ISTA/D.</p>

Replace contaminated components.

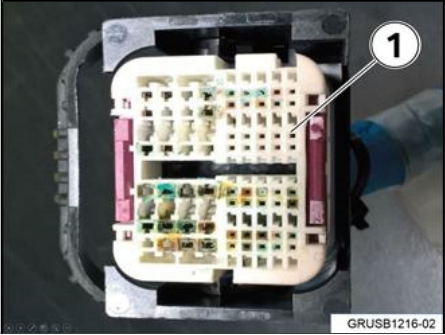
<p>GRUSB1216-02</p>	<ol style="list-style-type: none"> 2. Check the wiring harness connector at the DME for coolant (1). <p>Is there any coolant at the DME harness connector?</p> <p>YES – Continue to step 3.</p> <p>NO – Repair is complete.</p>

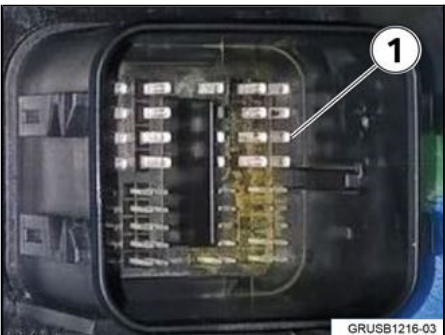
<p>GRUSB1216-03</p>	<ol style="list-style-type: none"> 3. Check the DME and PDM connector sockets for coolant contamination (1). <p>Is there any contamination at the electrical connectors for the DME or PDM?</p> <p>YES- Submit a TC case to the TC DME group for DME and PDM parts replacement approval</p> <p>NO- Repair is complete.</p>

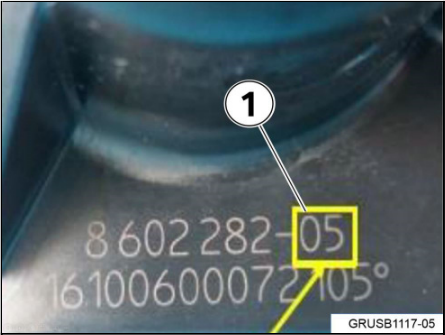
<p>GRUSB1117-05</p>	<p>UPDATE! Check the index number (1) on the new thermostat (PN 11 53 8 602 282). Improved service parts have an index number</p> <p>UPDATE! "05" or later. Do not install a thermostat with an index lower than "05".</p>
